Sepik Development Project

Appendix 12a – Vanimo Ocean Port Marine Ecology
Baseline Study

Sepik Development Project – Vanimo Ocean Port Marine Ecology Baseline Study

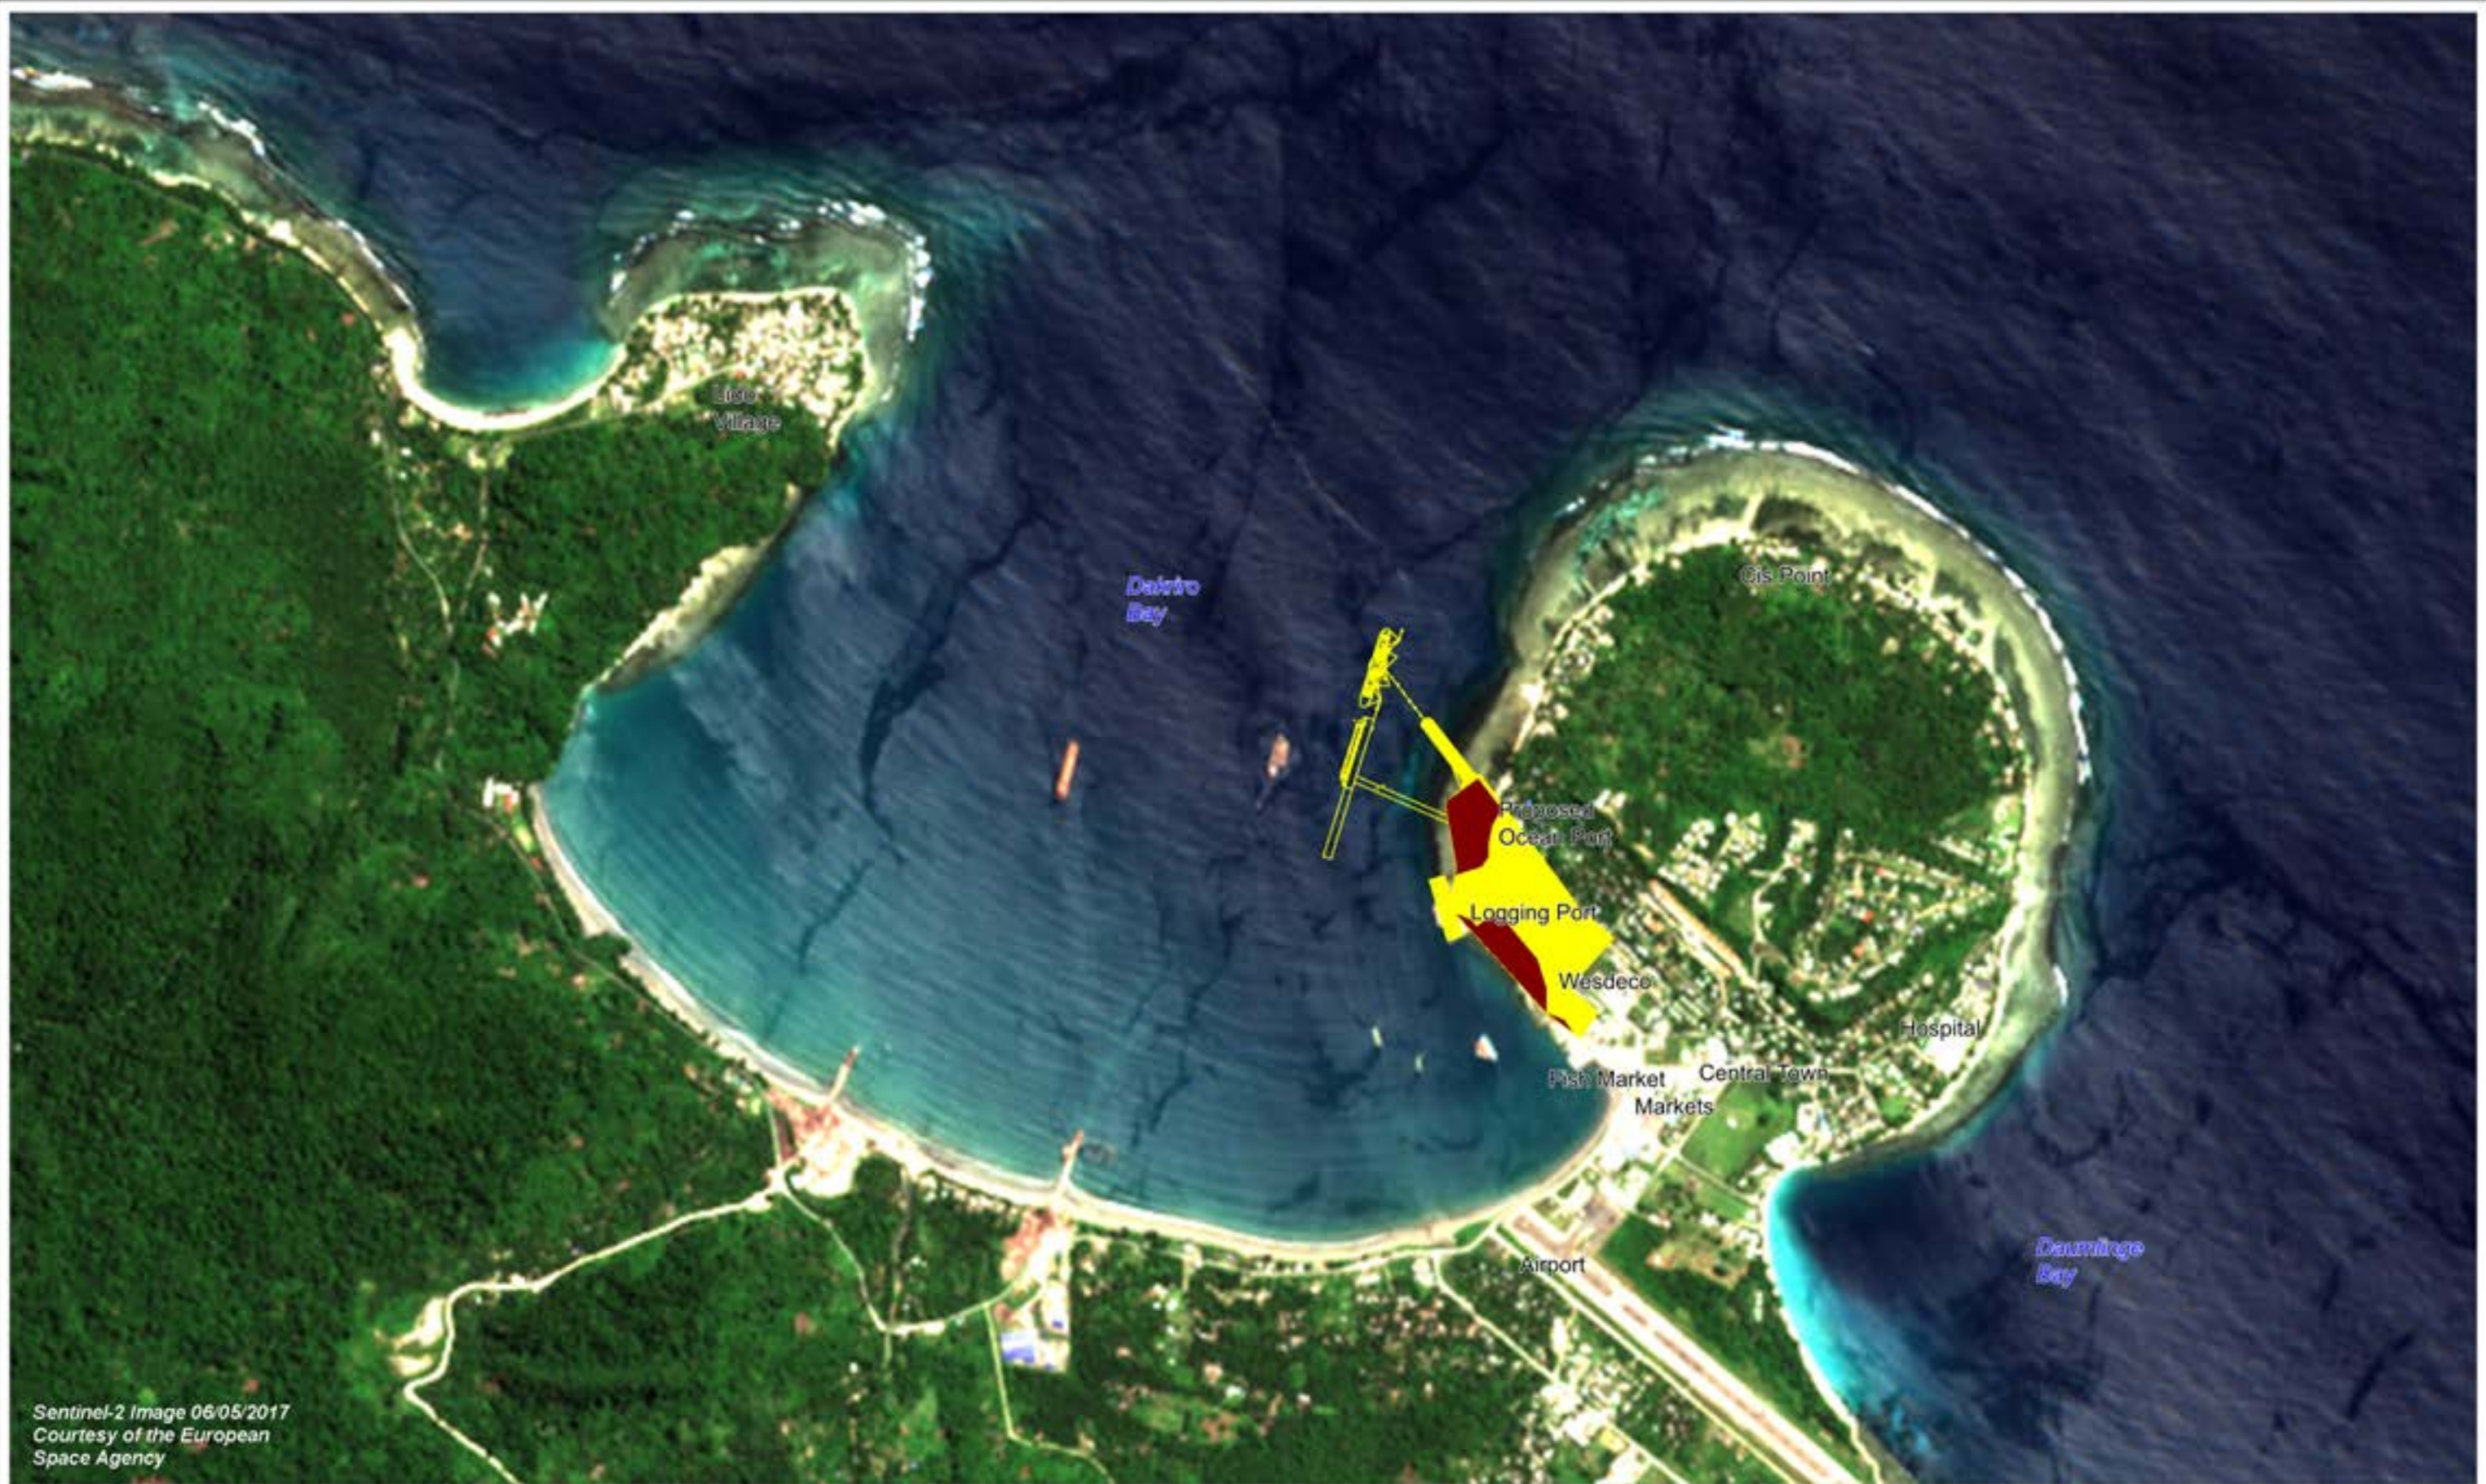
Figure:
1-2

This study focused on the area that comprises the nearshore marine environment at the Ocean Port. The proposed concept design for the Ocean Port is shown in Figure 1-2.

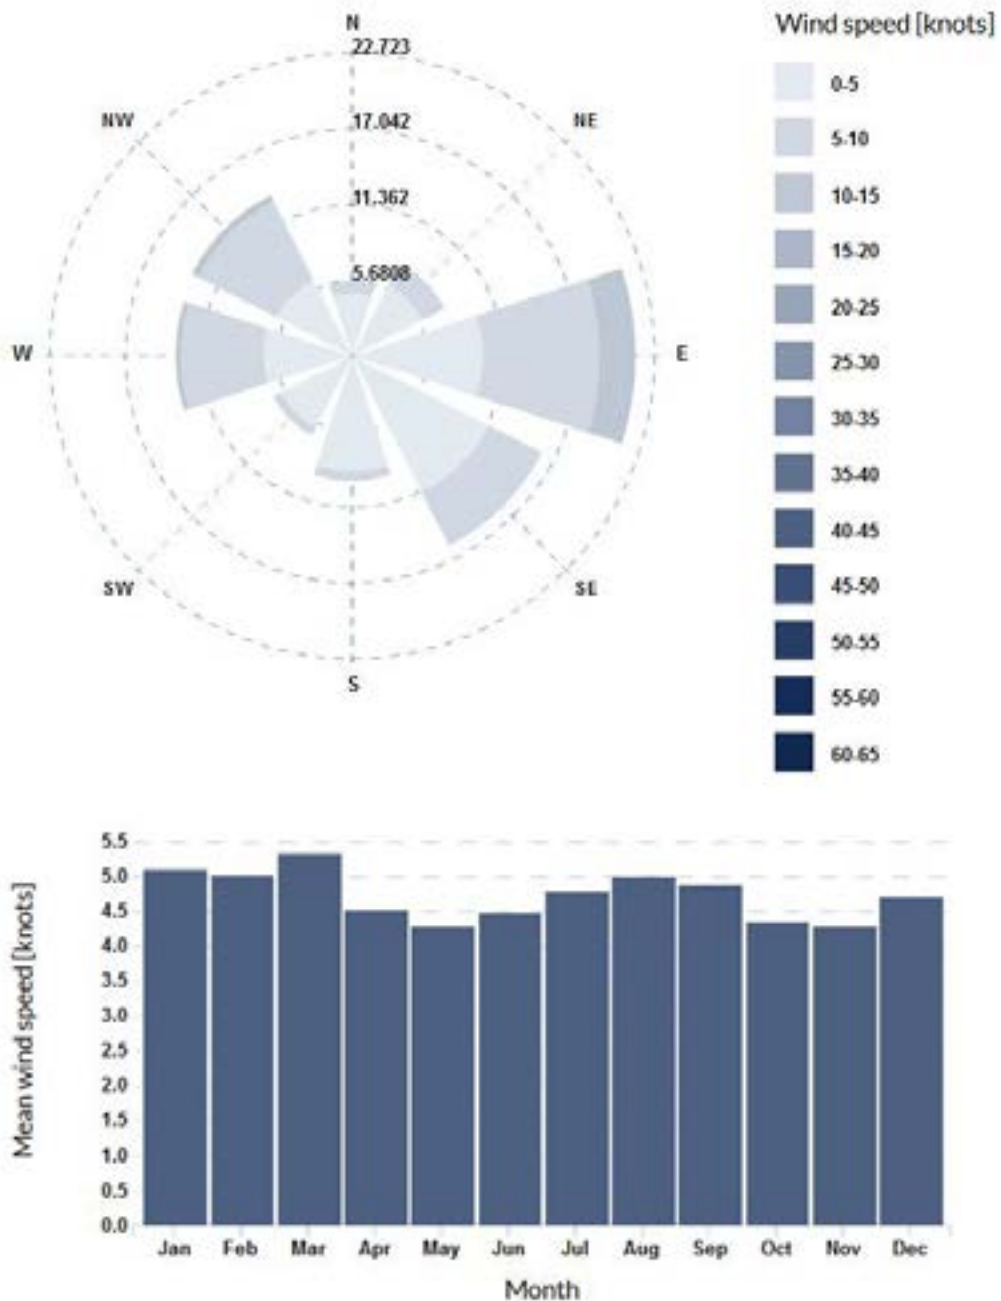
Figure 1-3 Model hindcast wind conditions from NOAA CFSR for Vanimo: Wind rose (above) and monthly average wind speed (below) (www.metocean.co.nz)

Papua New Guinea has a tropical climate, with the majority of the country experiencing high annual rainfalls, high average temperatures and high humidity. Vanimo's climate is typified by moderate seasonality (small temperature differences between the wet and dry seasons) and a moderate range in rainfall variability (intermediate to heavy), with the maximum rainfall experienced in January to April (McAlpine *et al.* 1983). The proximity to the equator sees sub-equatorial doldrum conditions and light winds over much of the year. Stronger winds typically come from either the east (dry season) or west to north-west (associated with wet season monsoon) (Figure 1-3). Most of the time (99 percent) winds speeds are less than 20 knots.

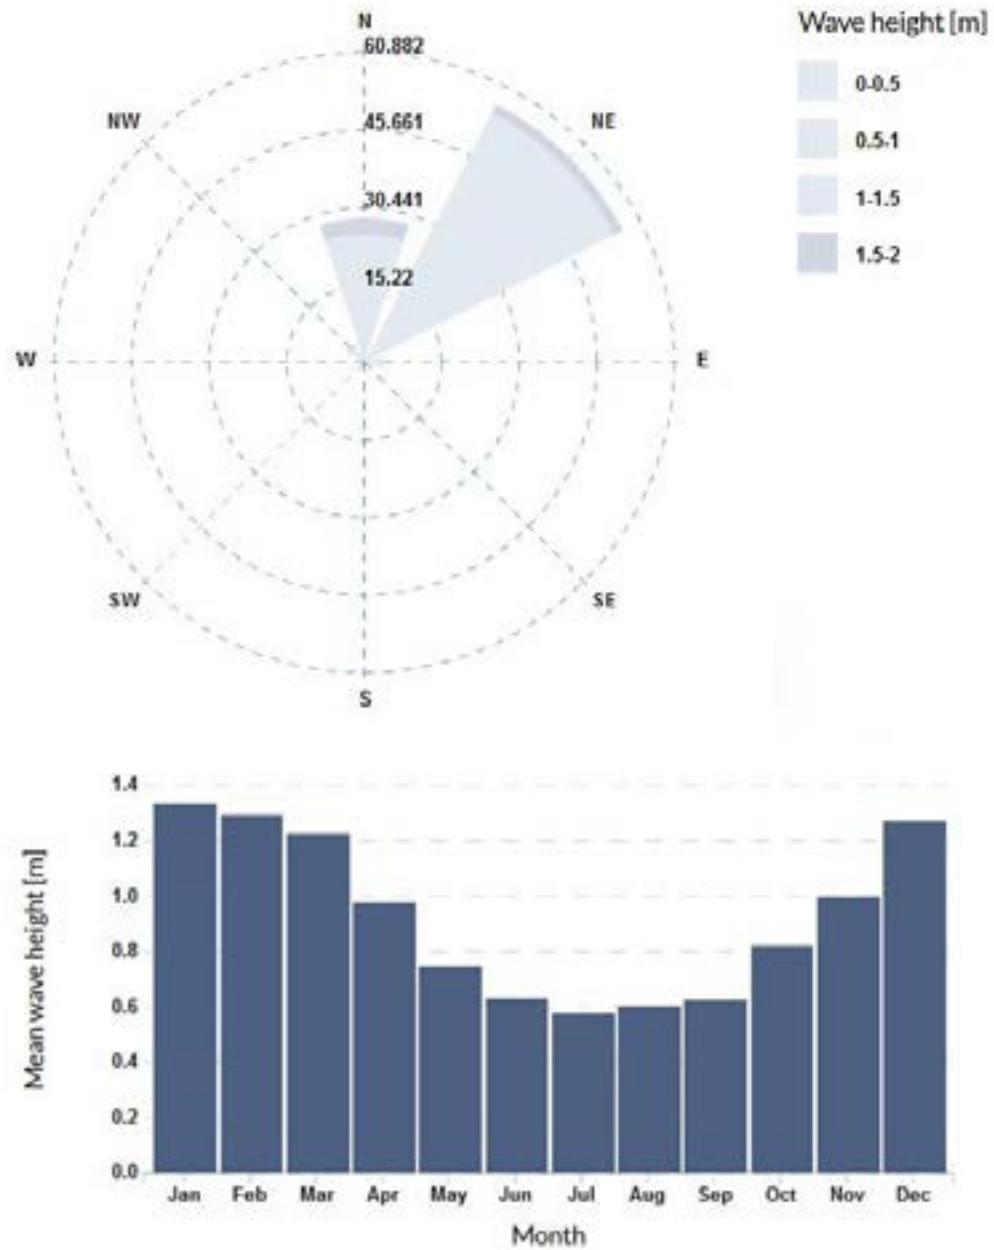
Figure 1-4 Model hindcast wave conditions from MSL SWAN for Vanimo: Wave rose (above) and monthly average significant wave height (below) (www.metocean.co.nz)

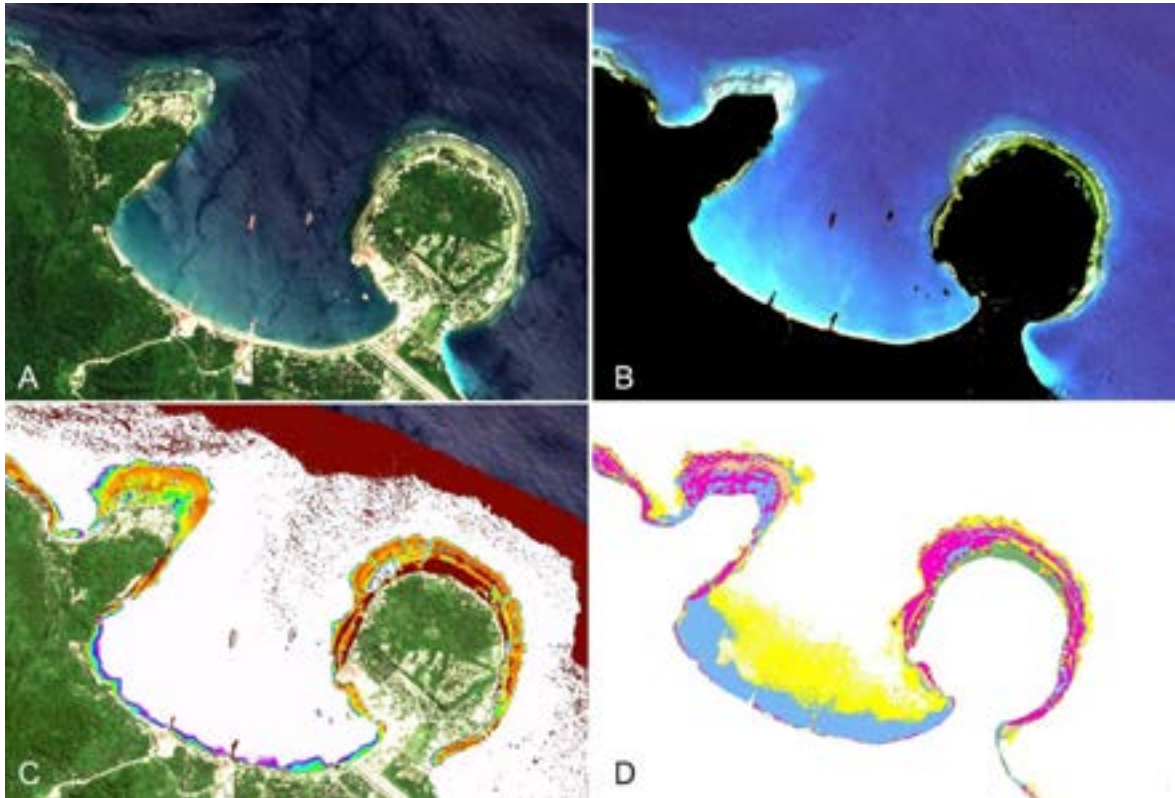
Figure 2-1 Sentinel-2 natural colour (A); deglinted and masked image (B); intensity of the benthic reflective index for the green band (C); and classified habitats (D).

Ground-truthing of representative habitats was used to determine spectral signatures and applied to the whole dataset. This was done with a supervised classification of the different Benthic Reflective Indices for blue, green and red bands to determine areas of high-coral cover, seagrass, macroalgal dominated reef, and sand and rock layers at different depths. Ground-truthing was also performed in representative habitat types and at intervals in waters too deep or too turbid to be remotely sensed. A visual representation of this process is shown in Figure 2-1.

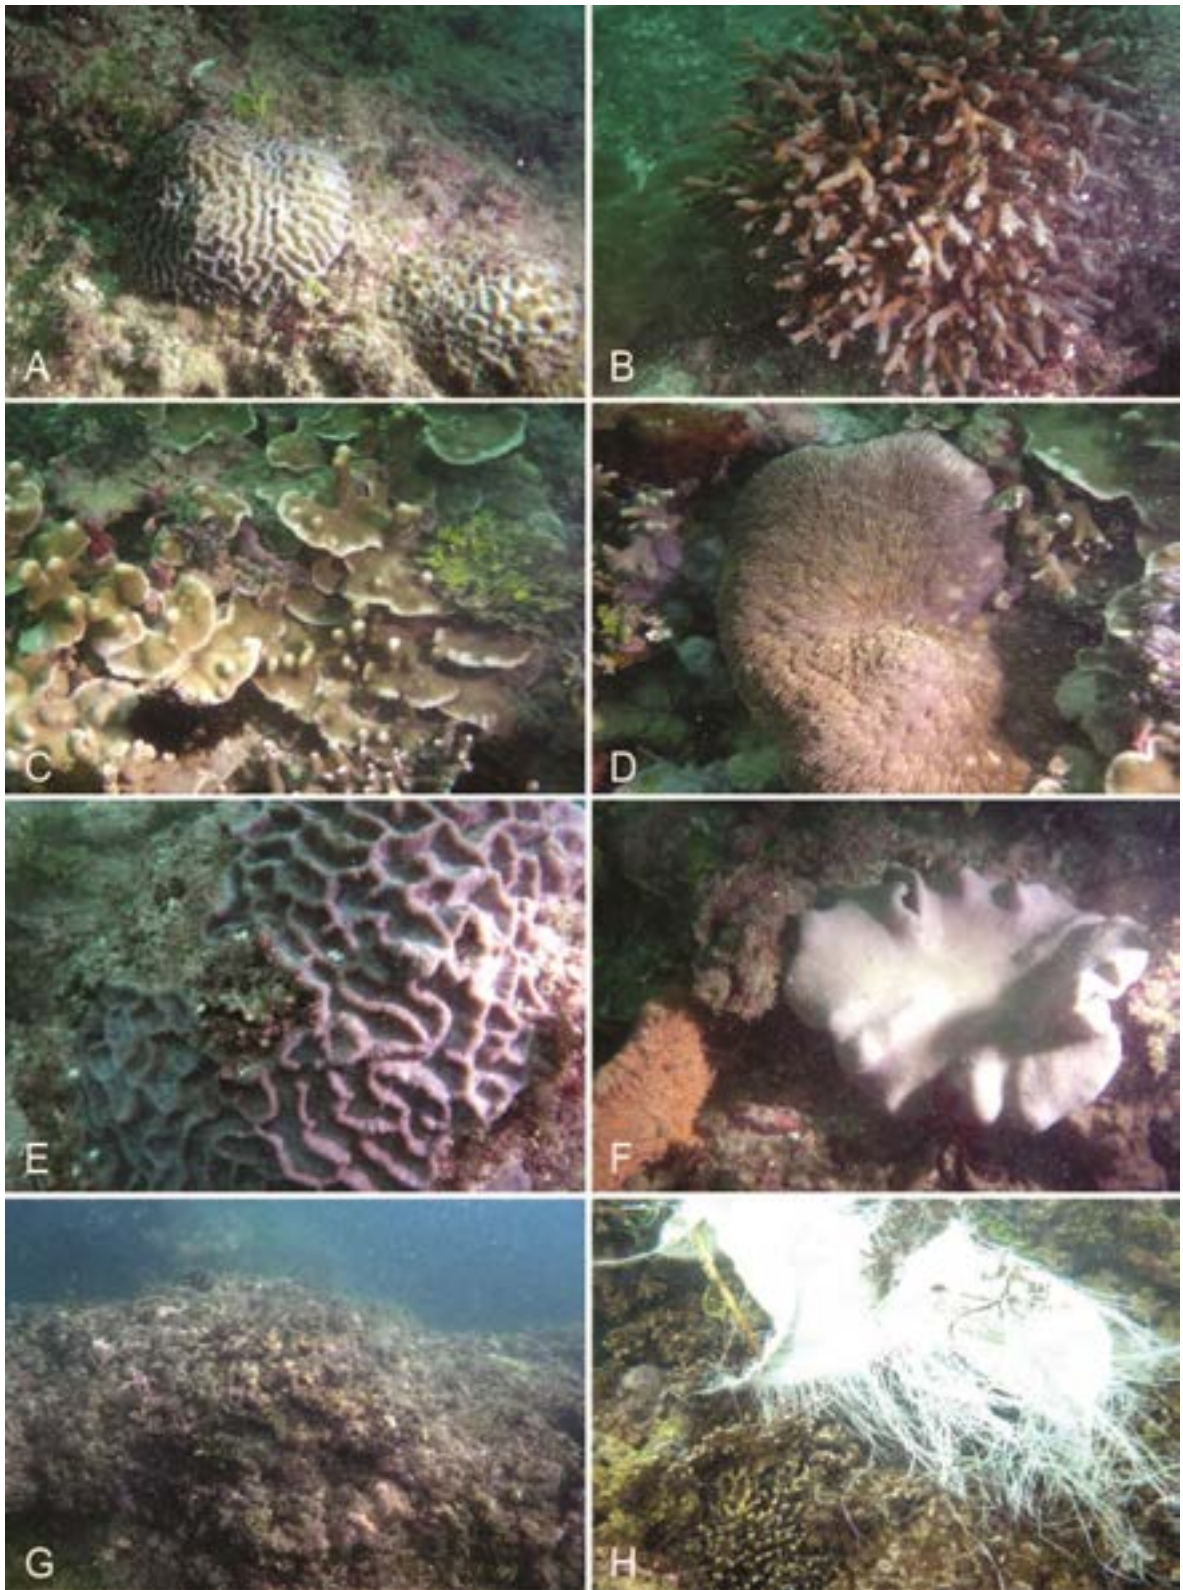
Figure 3-5 Coral communities on reefs near the proposed ocean port: (A) *Leptoria* and *Montastrea*; (B) *Seriatophora*; (C) *Porites*; (D) *Sandolitha*; (E) *Oulophyllia*; (F) *Sarcophyton*; (G) spur and groove formation on the reef front; (H) plastic waste

Sections of fringing reef exposed to high wave energy have a well-established reef crest, composed of cemented coral fragments with a dense covering of *Turbinaria* algae. These form short (a few centimetres) to long (1 m) ropes of algae in the wave-break area, with very high wave-energy areas having shorter strands. *Turbinaria* is heavily calcified yet flexible, and its movement affects the ability of corals to settle and survive due to physical abrasion. Wave climate, although highly seasonal (Section 1.5.2), is significant enough to create large spur and groove formations on the reef fronts (Figure 3-5 G).

Reef slopes typically had the highest cover of living coral, but this was highly variable among ground-truthing sites located in close proximity (Figure 3-4). Very high coral cover was observed at one location on the reef slope near the proposed ocean port (representing a large coral outcrop), but generally it was low and had an overall average cover of almost 13% on the reef slope and crest (Appendix A, Table A-1). Twenty genera were observed, and up to eight coral genera were recorded in any one transect. Example imagery from the reef near the proposed ocean port is shown in Figure 3-5.

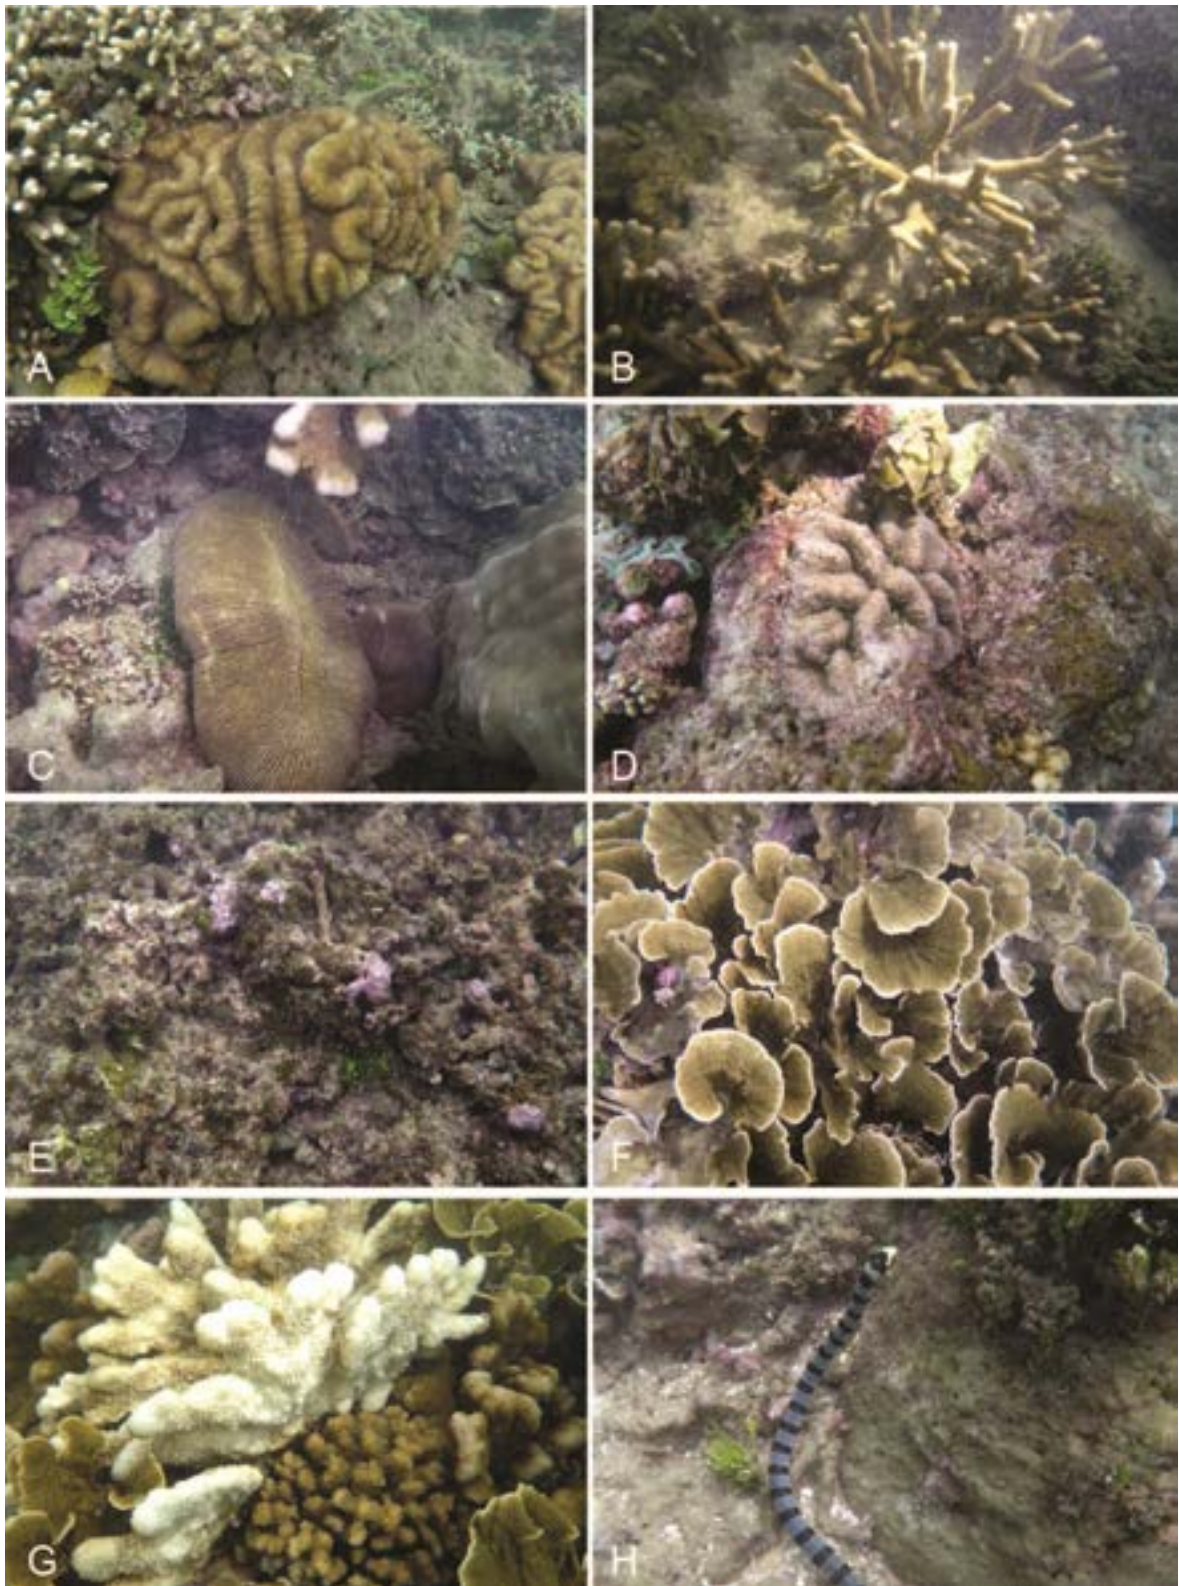
Figure 3-6 Coral communities of the Lido Village fringing reef: (A) *Lobophyllia*; (B) *Porites latistella*; (C) *Ctenactis* and *Fungia*; (D) *Symphyllia*; (E) crest community; (F) dense stands of plating *Montipora*; (G) bleached *Isopora palifera*; (H) banded sea krait *Laticauda colubrina*

Sample photos from the reef near Lido Village are shown in Figure 3-6. Reef communities at the northern extremity of Lido Village were not assessed due to large breaking waves at the time of the survey. However, local guides suggested that the area supported some of the best reef in Dakriro Bay in terms of coral cover and fish abundance.

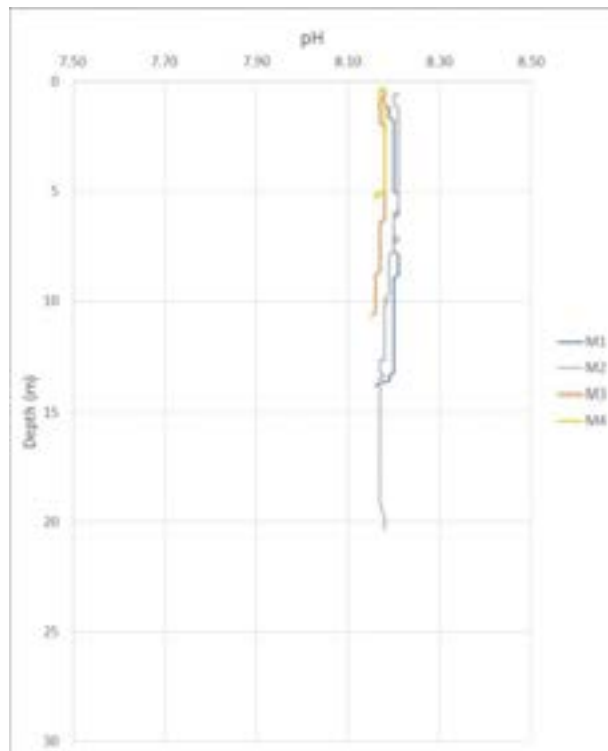
Figure 3-12 Water quality depth profiling data – pH
